DEPARTMENT OF TRANSPORTATION

Contract #: 04-0120F4Cty: SF/ALA Rte: 80 PM: 13.2/13.9File #: 1.28**WELDING INSPECTION REPORT****Resident Engineer:** Casey, William**Address:** 333 Burma Road**City:** Oakland, CA 94607**Report No:** WIR-029513**Date Inspected:** 10-Apr-2013**Project Name:** SAS Superstructure**OSM Arrival Time:** 700**Prime Contractor:** American Bridge/Fluor Enterprises, a JV**OSM Departure Time:** 1730**Contractor:** American Bridge/Fluor Enterprises, a JV**Location:** Jobsite**CWI Name:** See below**CWI Present:** Yes No**Inspected CWI report:** Yes No N/A**Rod Oven in Use:** Yes No N/A**Electrode to specification:** Yes No N/A**Weld Procedures Followed:** Yes No N/A**Qualified Welders:** Yes No N/A**Verified Joint Fit-up:** Yes No N/A**Approved Drawings:** Yes No N/A**Approved WPS:** Yes No N/A**Delayed / Cancelled:** Yes No N/A**Bridge No:** 34-0006**Component:** OBG**Summary of Items Observed:**

WELDING INSPECTION REPORT

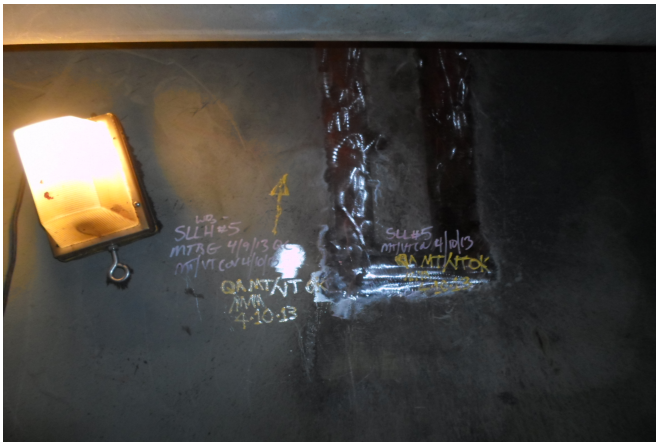
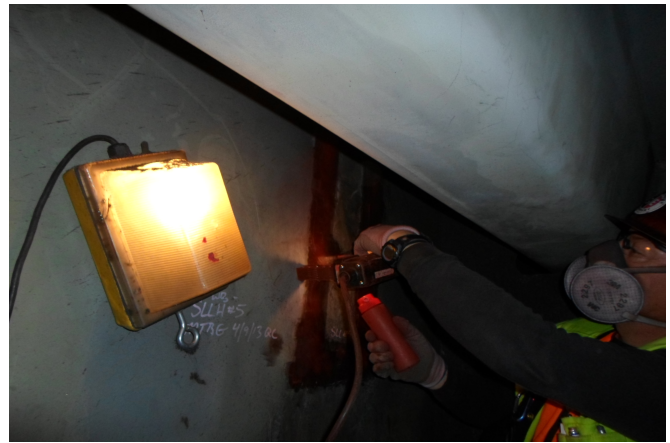
The digital photographs below illustrate some of the work activities observed on this date:
